#### **Monochromator Vibration Considerations**

Mechanical Engineering and Design Group
Advanced Photon Source
Argonne National Laboratory

ESRF DCM Workshop, 13<sup>th</sup> and 14<sup>th</sup> May, 2014

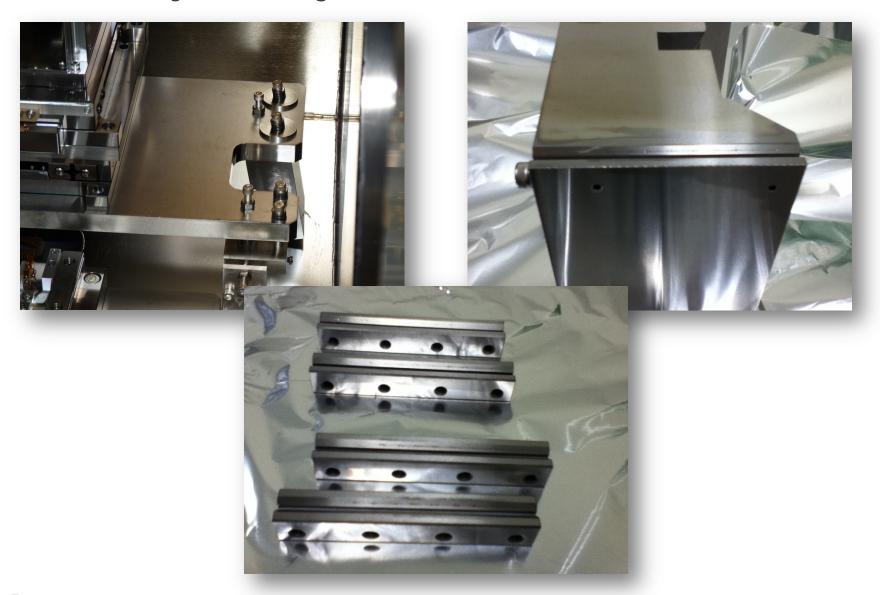
# Case Study 1: Mirages

- Initial beam characterization was misleading
  - Camera frame rate was insufficient.
  - Operational conditions were be different than conditions when imaging beam vibration were different than when measuring vibration
  - A roughing pump was connected to an evacuated flight path in the next hutch
- A number of "mirages"
  - Missing fasteners
  - Broken/incorrect baseplate mounting
  - Damaged vertical stage, fretting
- Cycle times between measurements were long
- Access to internals was limited
